SUMMARY
12345 N Main Street , Anytown, OK,
USA
Jim Holland
January 7, 2023

Jim Holland
American Home Inspector Training®
(AHIT) Graduate, InterNACHI Certified
Professional Inspector®, 20 Years of
Professional Fire Service
Holland Home Inspections, LLC
918-378-5017
jim@hollandhomeinspections.com

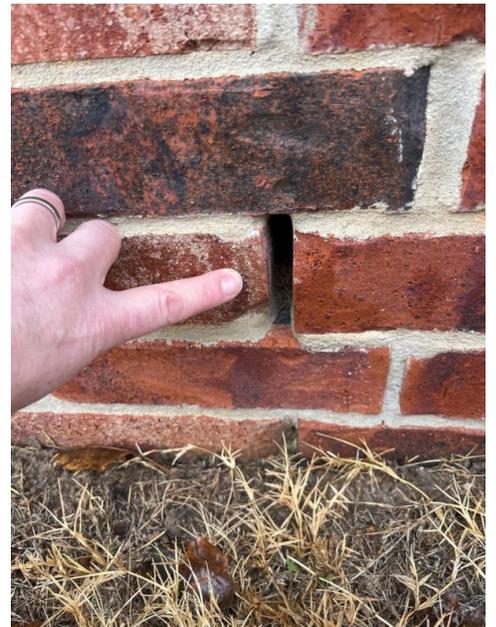
2.2.1 Siding, Flashing & Trim

WEEP HOLES OPEN

Brick Veneer Weep Holes were found to be open. This may be or become an entry point for insects or other pests. Recommend installing weep hole protectors designed for that purpose. The proper device will allow water to drain properly, but also keep out unwanted pests.

One example

Recommendation
Recommended DIY Project

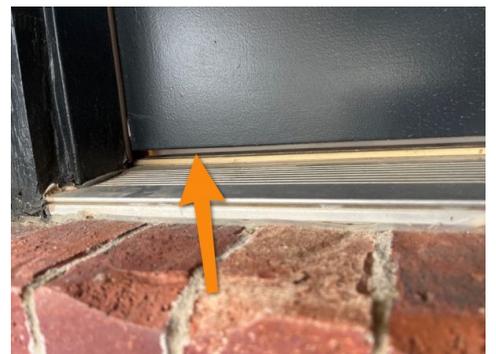
2.3.1 Exterior Doors

WEATHERSTRIPPING NOT PRESENT/INSUFFICIENT

Back Door was missing weatherstripping at the threshold. This can result in significant energy loss and moisture/air intrusion. Recommend installation or improvement of weatherstripping.

Back Door

Recommendation
Contact a handyman or DIY project

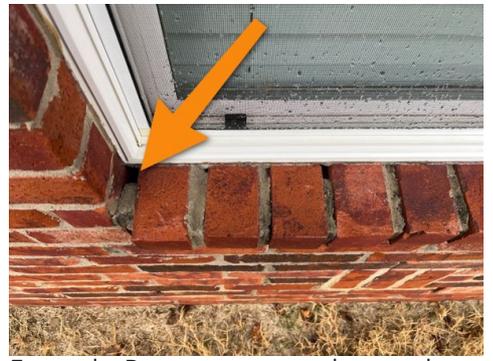
2.4.1 Windows

GAPS

Window or surrounding area (siding, frame, veneer, etc) was found to have gaps, which may allow the elements or pests in. This may contribute to moisture-related problems, or have a negative effect on the structure. Recommend sealing gaps to prevent water penetration.

Example. Present at several ground floor windows.

Contact a qualified professional.

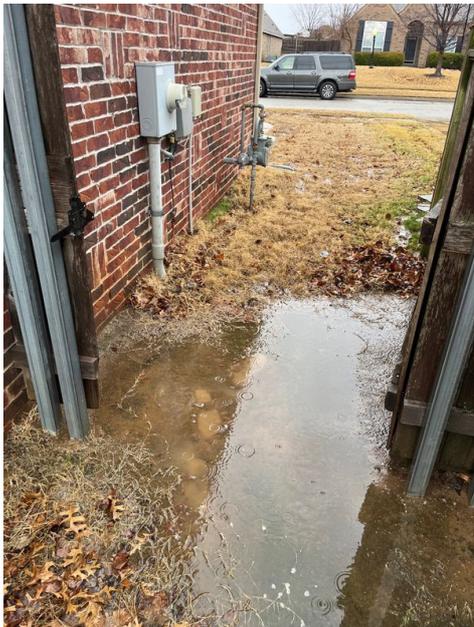
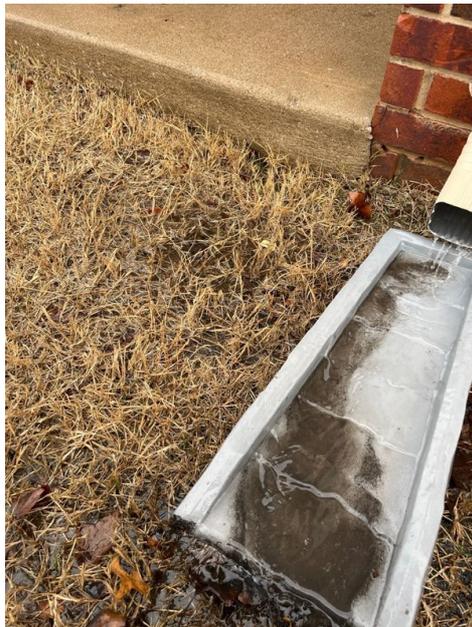
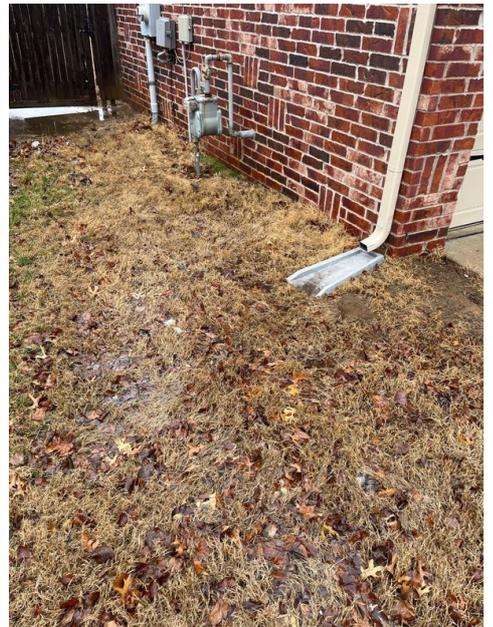
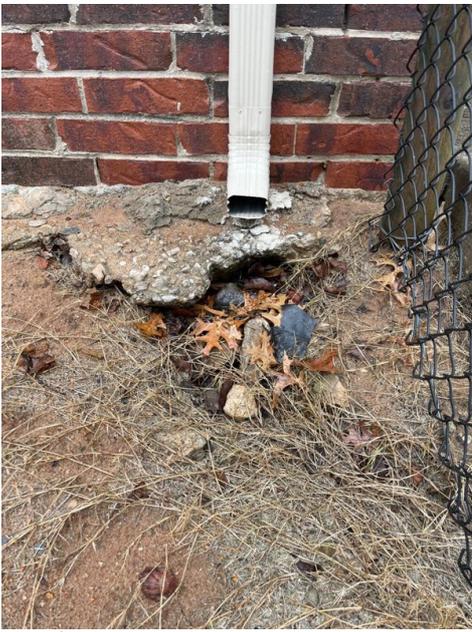
2.10.1 Grading, Drainage, Vegetation & Retaining Walls

INEFFECTIVE DRAINAGE

Water was ponding near the structure, indicating poor drainage. Recommend monitoring, and contact landscape or foundations professional to evaluate and remedy drainage.

Even where some splash blocks were employed, standing water and soil washing was noted. Recommend adding drain extensions from downspouts where water ponds and where soil was being eroded.

At gate

At back patio

Near Utilities

Northwest corner

Recommend monitoring.

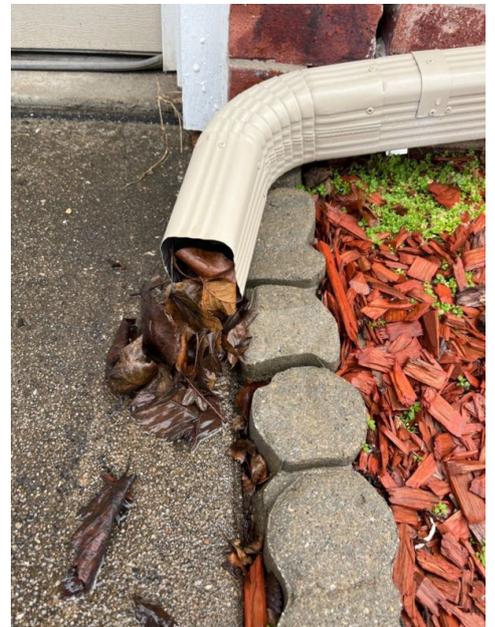
3.2.1 Drainage

DEBRIS

Debris was accumulated in gutter/downspout. Recommend cleaning regularly to facilitate water flow, and to avoid potential water damage or gutter failure, caused by weight accumulation from water. During inspection, water was flowing well.

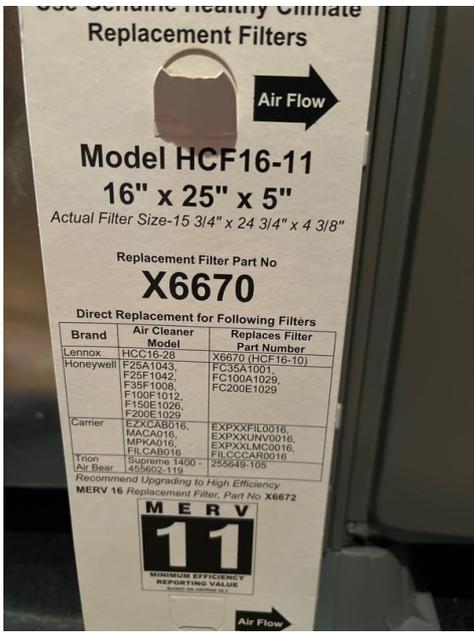
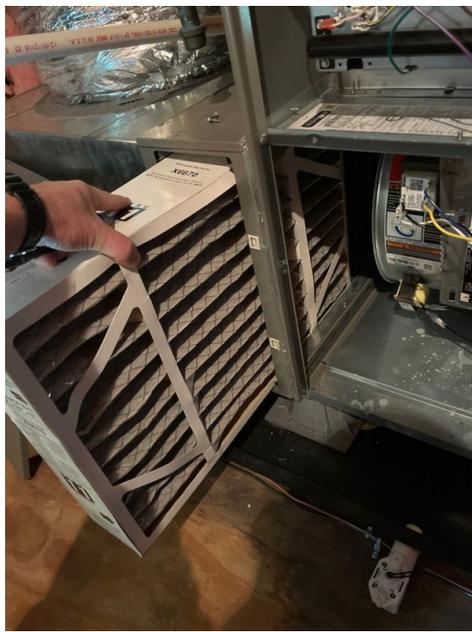
5.3.1 Equipment (1)

FILTER DIRTY

The furnace filter was dirty and must be cleaned or replaced regularly. Schedule will be determined by filter style and media type, amount of use, household conditions, and manufacturer's recommendations.

Recommendation
Recommended DIY Project

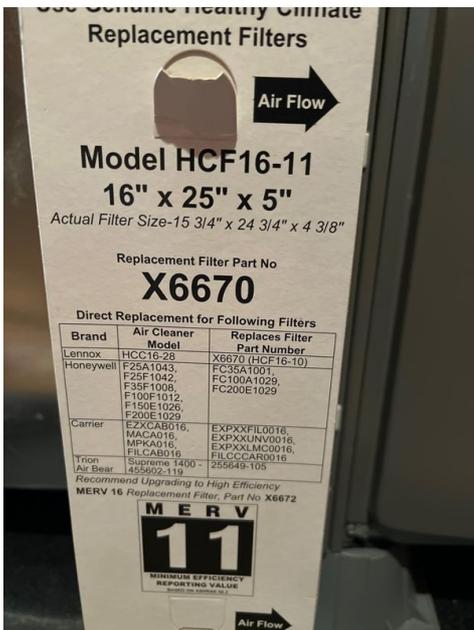
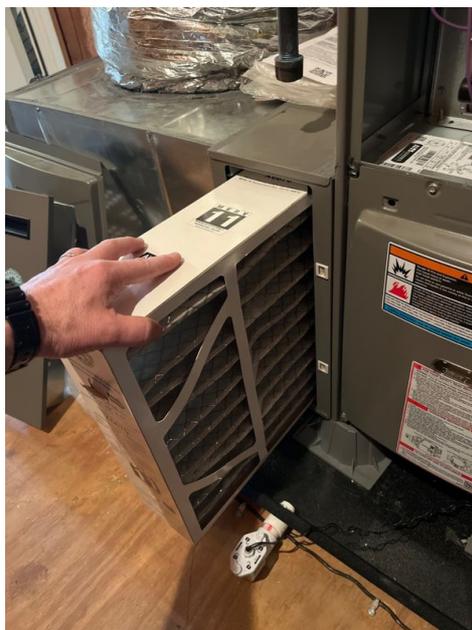
5.4.1 Equipment (2) FILTER DIRTY

The furnace filter was dirty and must be cleaned or replaced regularly. Schedule will be determined by filter style and media type, amount of use, household conditions, and manufacturer's recommendations.

Recommendation
Recommended DIY Project

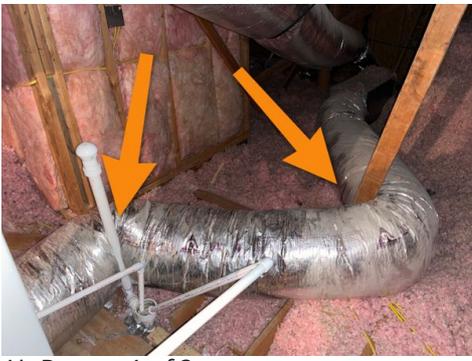
5.5.1 Distribution System DUCT RADIUS TOO TIGHT

Air ducts had tight bends in them which may reduce airflow. If low air flow or temperature irregularities are noticed during use, evaluation by HVAC professional, and possible rerouting are recommended.

Air Return 1 of 2

Recommendation
Contact a qualified HVAC professional.

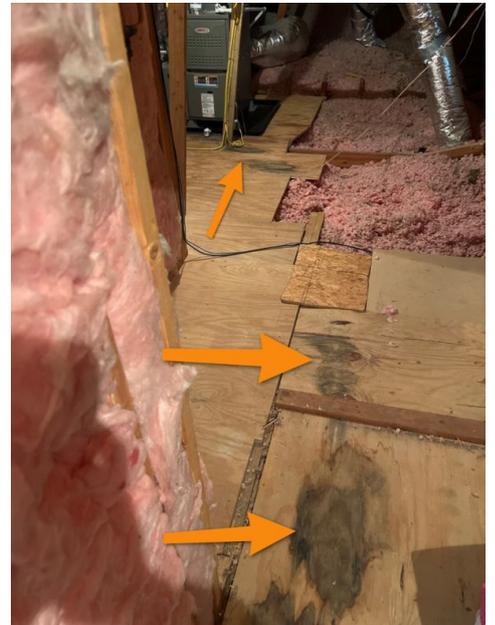
6.3.2 Inside Equipment (1)

WATER STAINS NEAR REFRIGERANT LINES

Water Stains were found near/underneath refrigerant lines. No moisture was noted during inspection. This may be an indication of previous freezing and thawing of low-pressure line. Freezing may be caused by issues such as restricted airflow, or low refrigerant pressure. It is recommended that an HVAC professional evaluate the system, and make any necessary repairs.

Contact a qualified HVAC professional.

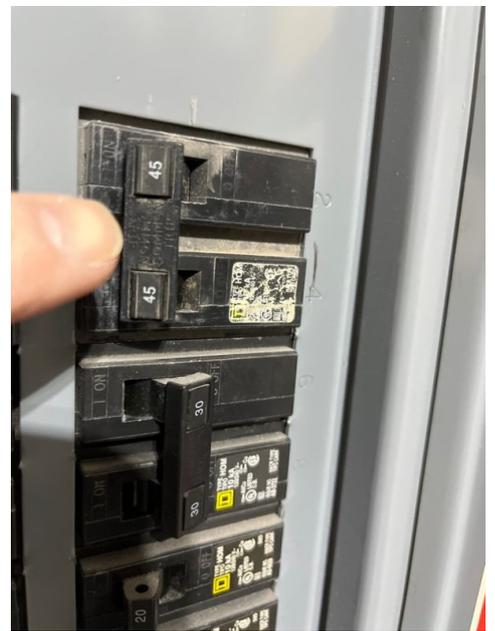
6.5.1 Outside Equipment (1)

CIRCUIT BREAKER OVER-SIZED

AC Unit was found to be on an "over-sized" circuit breaker. This means that the circuit breaker assigned to it is larger than recommended by the manufacturer, and will allow more current to flow than is considered safe for the unit. In this condition, conductors (wiring) may be allowed to heat up due to over-current, potentially resulting in fire, or the unit itself may be otherwise damaged. This condition sometimes occurs when a new, more efficient condensing unit is installed, and the circuit breaker is not changed to match. It is recommended that a licensed electrician evaluate and replace the circuit breaker as necessary.

Max 35 listed

Contact a qualified electrical contractor.

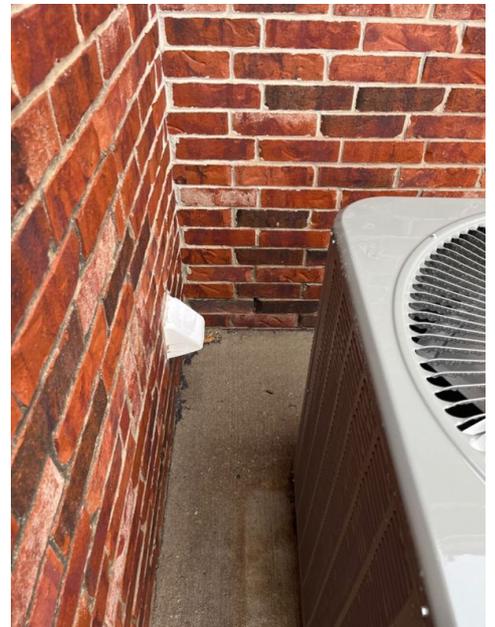
6.5.2 Outside Equipment (1)

UNIT TOO CLOSE TO CLOTHES DRYER EXHAUST

Unit was found to be mounted too close to clothes dryer exhaust. This exhaust port emits moist air which may shorten the unit's life. Additionally, it emits any lint which bypasses the dryer's screen. This lint accumulates on the condensing unit's fins, impeding air flow, and negatively affecting operation. It is recommended that the unit be checked for lint regularly, and cleaned with a garden hose as needed.

Recommended DIY Project

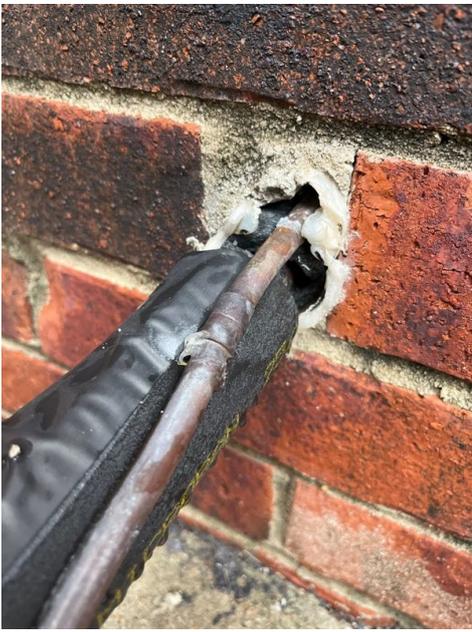
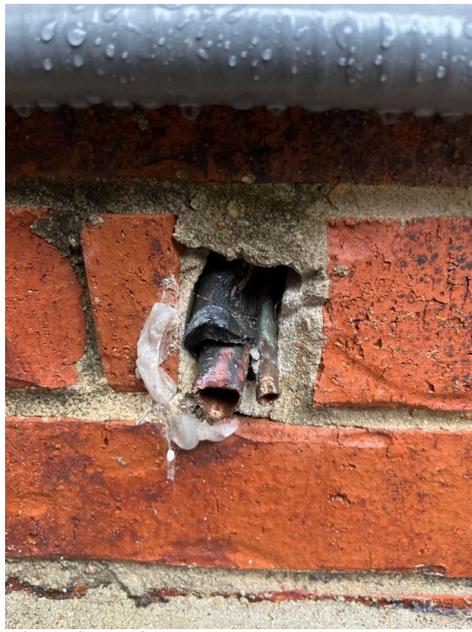
6.5.3 Outside Equipment (1)

WALL PENETRATIONS

Line Set(s) penetrated house through wall. Recommend better sealing this gap to prevent pests and elements from entering.

Current

Abandoned

Contact a qualified professional.

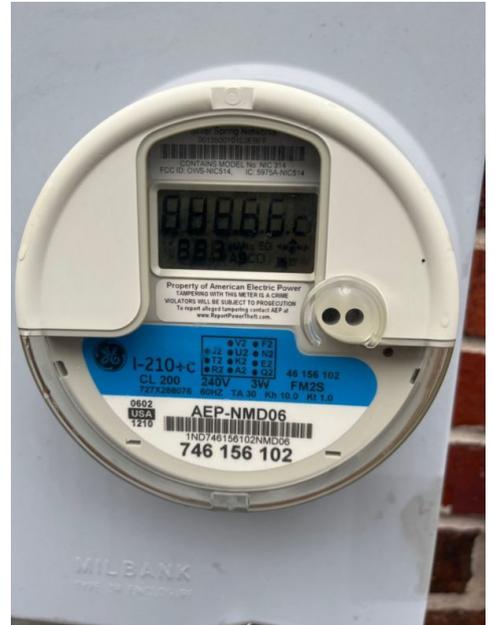
7.2.1 Meter **UNREADABLE**

Meter face was unreadable. For any questions, recommend contacting utility company.

Recommendation
Contact your local utility company

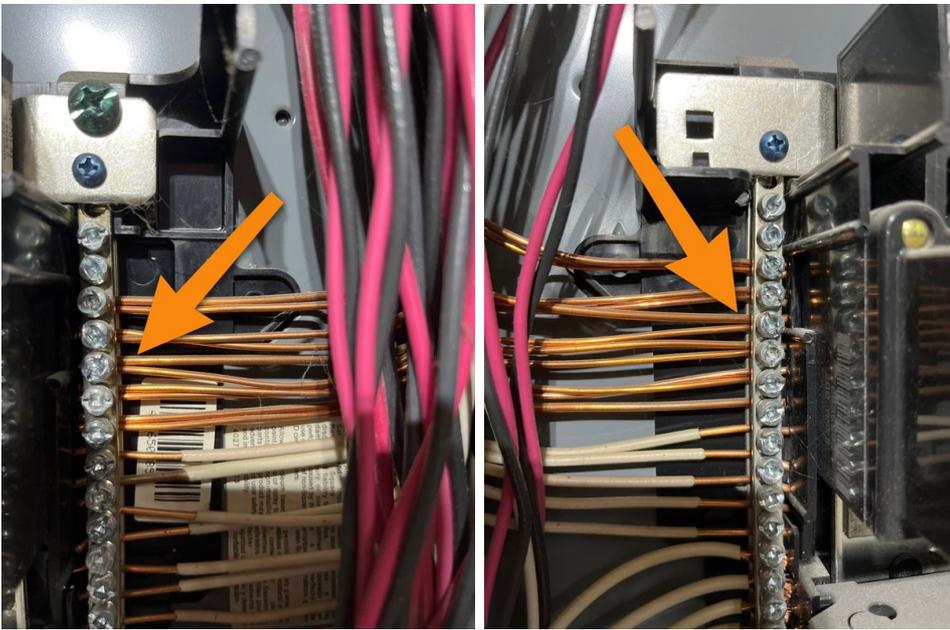
7.4.1 Main & Subpanels, Conductors, Overcurrent Devices **DOUBLE-TAPPED GROUND (INCOMPATIBLE)**

Incompatible grounding conductors were found to be double-tapped. Up to 2 wires may be accommodated under one lug, but must be of the same material and wire gauge. It is recommended that this be corrected by a qualified professional. Conductors of different sizes may become loose, reducing ground's effectiveness, and presenting a safety hazard.

Recommendation
Contact a qualified electrical contractor.

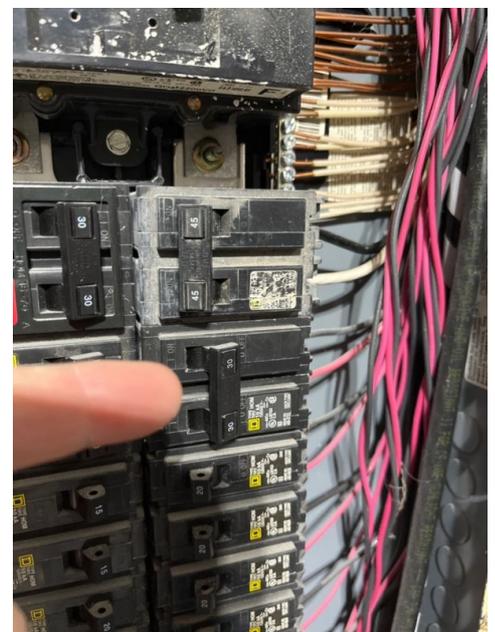
7.4.2 Main & Subpanels, Conductors, Overcurrent Devices

BREAKER/FUSE FOUND OFF

An overcurrent device was found in the "off" position. It is recommended to inquire with current owner as to why. If unknown, a qualified electrician should evaluate. This could be due to an unused branch circuit, or due to a known problem circuit or appliance. This 240V circuit was labeled "Dryer", and a 110V gas dryer was noted in the laundry room.

Found Off

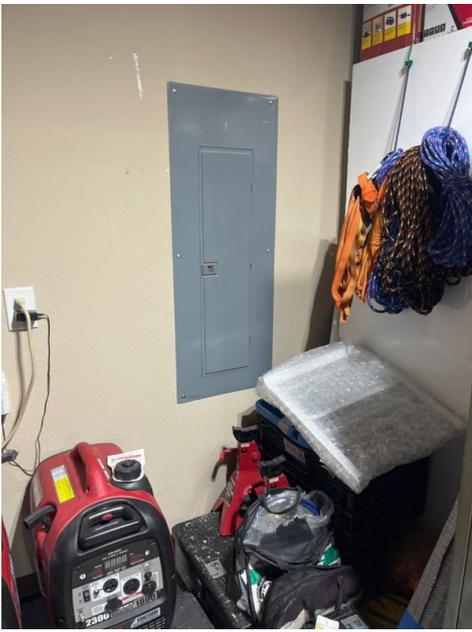
7.4.3 Main & Subpanels, Conductors, Overcurrent Devices

PANEL OBSTRUCTED

Main Electrical Panel was found to be obstructed. Panel should be provided with adequate clear space for access, at least 30" wide and 36" deep, from the floor surface to at least 78" high. It is recommended that storage be removed and area kept clear.

Recommendation
Recommended DIY Project

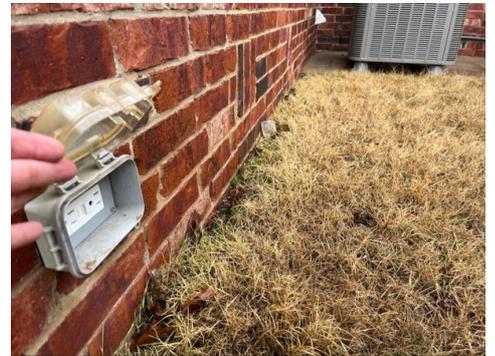
7.7.1 GFCI & AFCI

GFCI FAILED TO WORK

When tested, a GFCI failed to function as intended. These devices are installed to protect a user from electric shock during a ground fault condition. It is recommended that a qualified professional evaluate the GFCI and replace as necessary.

Exterior South

Contact a qualified electrical contractor.

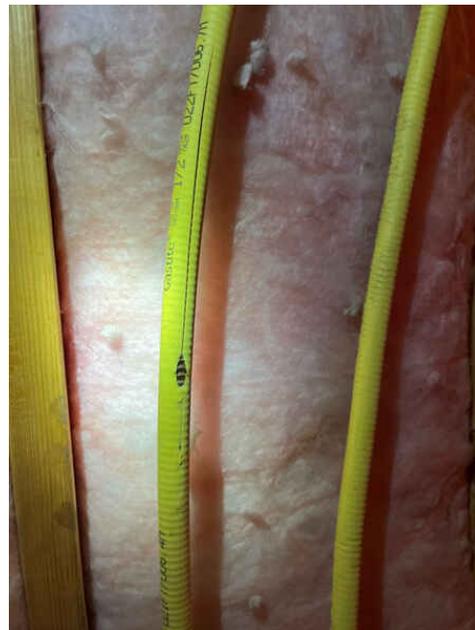
8.2.2 Fuel Storage & Distribution Systems

CSST SHEATHING DAMAGED

Damaged sheath

Recommend qualified professional for evaluation and any necessary repairs.

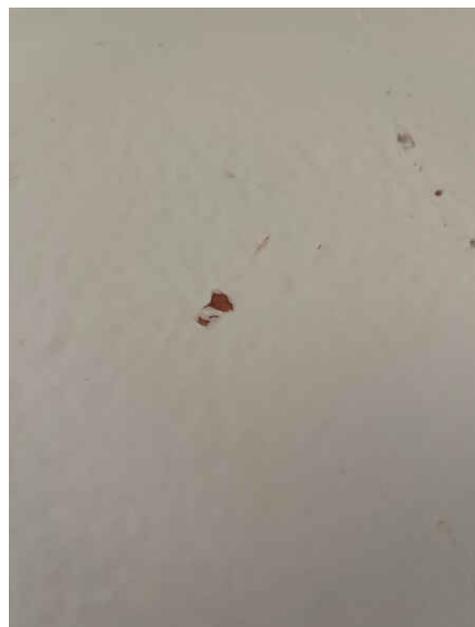
9.5.1 Surfaces of Tubs/Showers

SHOWER ENCLOSURE SURFACE(S)

Shower surface(s) were found to be damaged. Left unchecked, damaged surfaces around or under water are prone to further damage or failure, which may extend beyond the enclosure itself, and into adjacent components. Recommend evaluation and repair by qualified professional.

Small area of damage noted in 1st floor rear bathroom shower floor.

Shower Floor chipped

Contact a qualified professional.

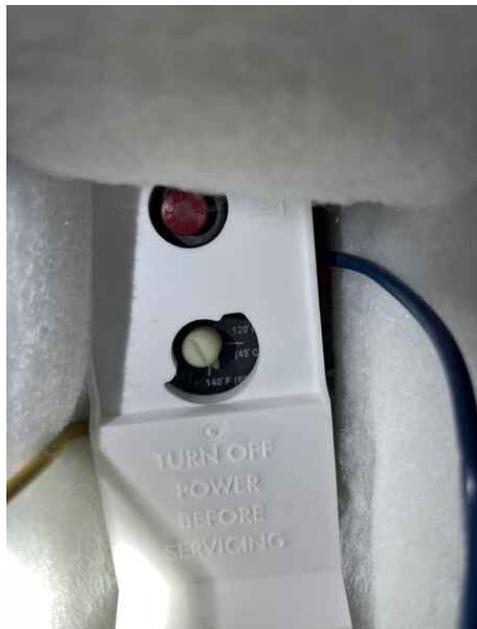
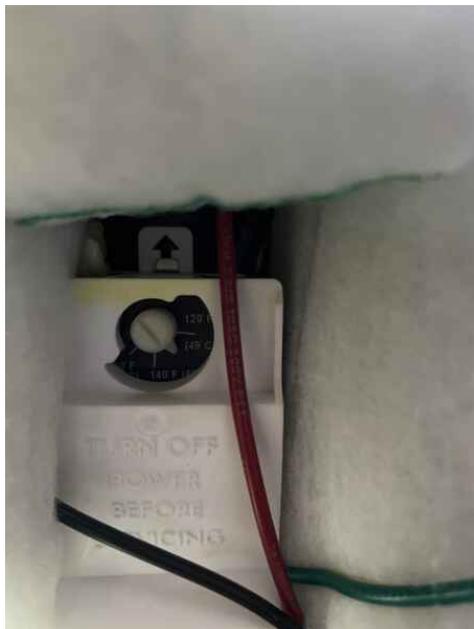
WATER TEMPERATURE

Hot water temperature was set higher than 120 F. Water set to approximately 120 F is generally considered safe. Hotter water can cause scald injuries. If higher temperature is maintained, use with caution. Adjustment to a lower temperature setting is recommended. *Please note, there is a mild risk of bacterial growth in water maintained lower than approximately 130-140 F.*

Upper Element

Lower Element

Contact a handyman or DIY project

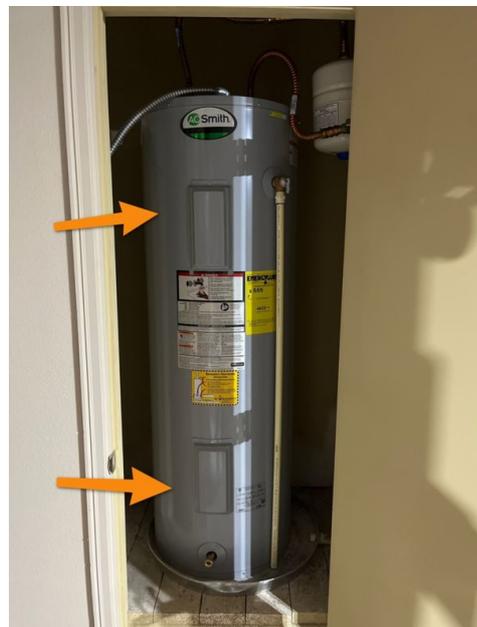
NO SEISMIC BRACING

Water Heater was found to be unprotected from movement during a seismic event. Tanks should be equipped with seismic straps (Top 1/3 and Bottom 1/3) to protect from movement during an earthquake or impact. It is recommended that appropriate strapping be performed.

No Seismic Bracing

Contact a qualified professional.

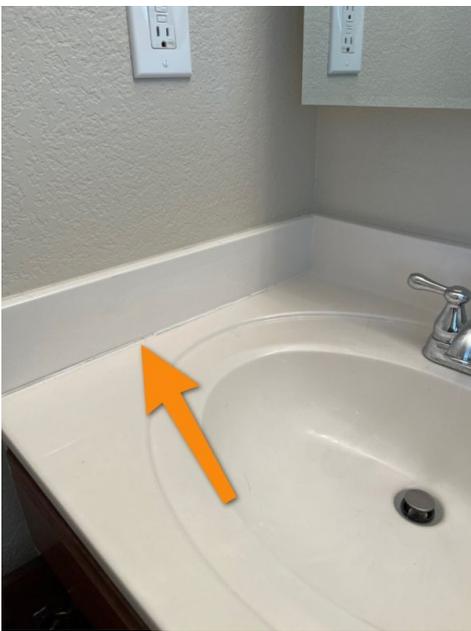
NEEDS CAULK/SEALING

Recommend recaulking backsplash to prevent water damage.

1st floor rear bath

Contact a handyman or DIY project

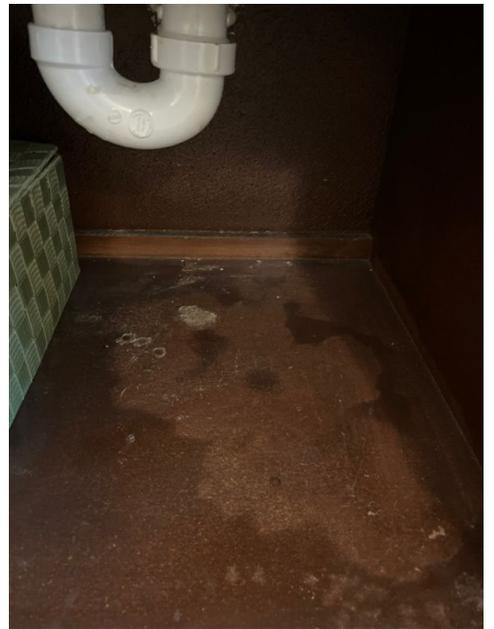
9.8.2 Plumbing Fixtures

SIGNS ON PREVIOUS LEAKAGE

Signs of previous leakage were noted. Leak was not active during inspection.

1st Floor rear bath, left sink

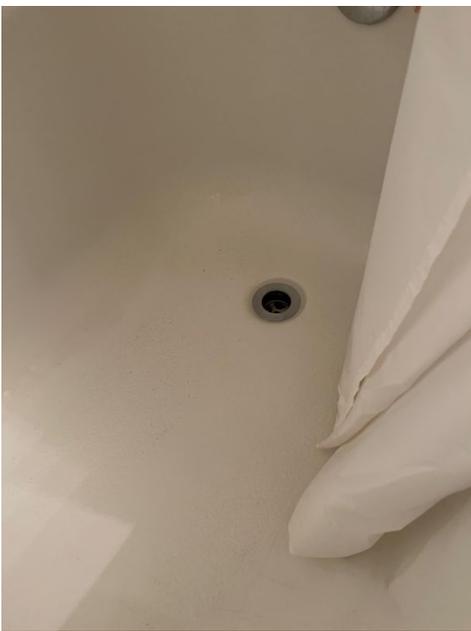
9.8.3 Plumbing Fixtures

NO STOPPER

Fixture drain was not equipped with a stopper. Recommend adding one.

2nd Floor bath

Contact a handyman or DIY project

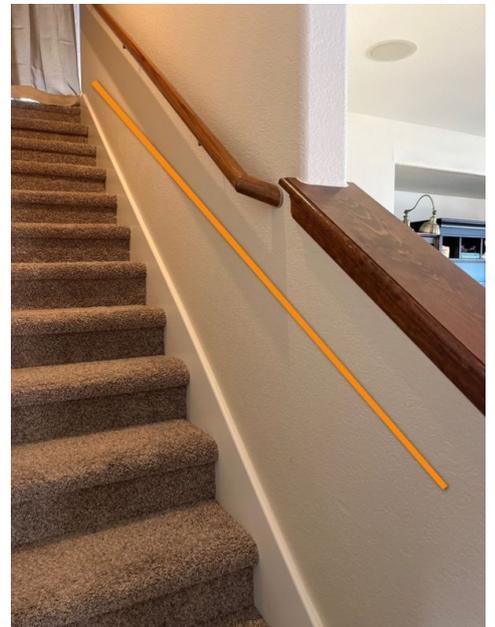
10.4.1 Steps, Stairways & Railings

HANDRAIL NOT CONTINUOUS

Handrail was not continuous. This is important for uninterrupted support during use. Recommend adding continuous handrail on at least one side.

Recommendation
Contact a qualified handyman.

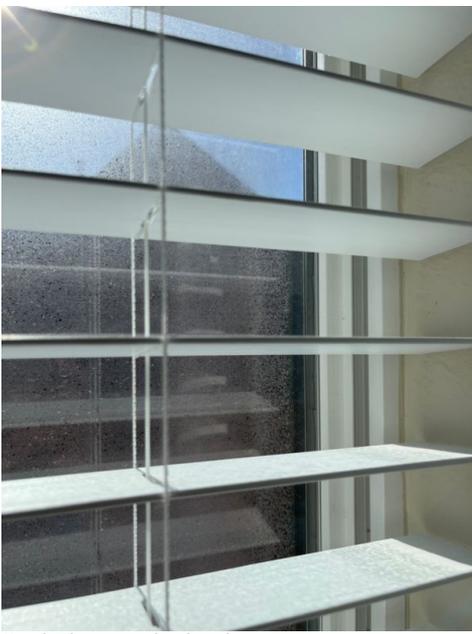
10.6.1 Windows

FAILED THERMAL SEAL

Observed condensation, fogging, or corrosion between the window panes, which indicates a failed thermal seal. This is primarily a cosmetic issue. Due to weather and/or lighting conditions, there may be other windows experiencing the same failure, which did not show-up during the inspection. Recommend qualified window contractor evaluate & replace as desired or necessary.

2nd Floor right bedroom

Recommendation
Contact a qualified window repair/installation contractor.

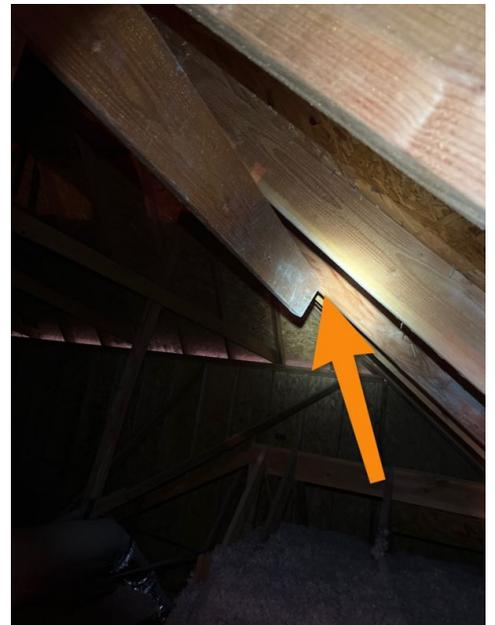
12.1.1 Roof Structure

SAGGING/DEFLECTION

The roof plane, just north of the northernmost dormer facing the street, appeared to have a minor sag/deflection along one rafter. From attic space, it was noted that the first full-length rafter located beyond the dormer-supporting purlin, was slightly lower than the adjacent supported rafters. This may indicate some sagging, or deflection caused by the purlin. No damage was noted to the rafter in question. Recommend a qualified roofer evaluate and repair as necessary.

Contact a qualified roofing professional.

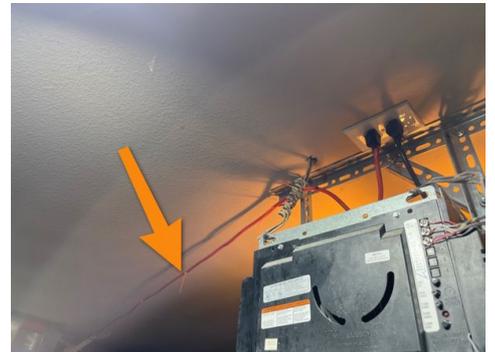
14.8.1 Electrical

EXTENSION CORDS

Extension cords were used for permanent wiring. This is a fire hazard. Recommend correction, and addition of electrical receptacles by licensed electrician if necessary or desired.

Contact a qualified professional.

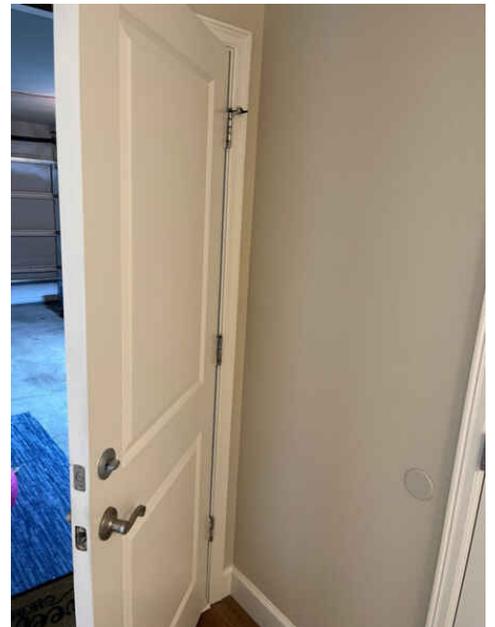
14.9.1 Occupant Door (garage-to-home)

NOT SELF-CLOSING

Door was not self-closing. Door from garage to home should have self-closing hinges/mechanism to help prevent spread of a fire to living space. Recommend a qualified contractor install self-closing hinges.

Not Self-closing
